Appendix F

Structures Inspection Results

FACILITIES CONDITION ASSESSMENT REPORT

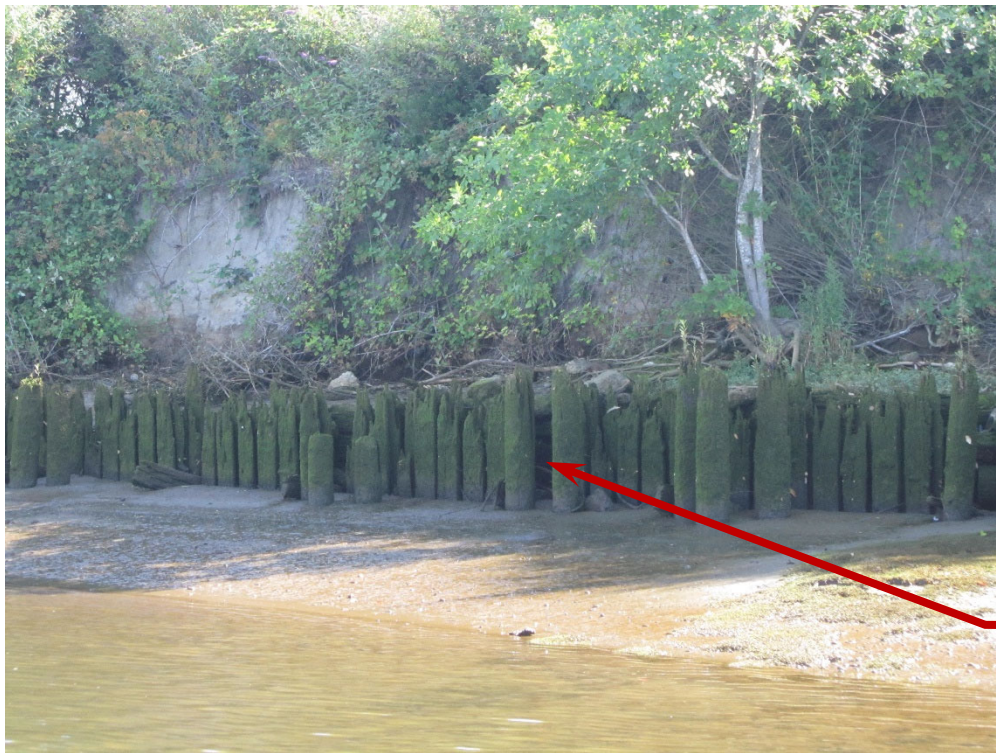
Photo ST03-19

- In the bank, protection consists of closely spaced timber stub piles with timber lagging behind the piles (Photos 19 to 25).
- The tops of the piles are generally rotted or splintered, but the lower sections appear sound (Photos 20 to 25).
- Lagging in a number of areas are rotted and soil erosion through the bulkhead was observed (Photos 22 to 25).
- Pile embedment and the condition below mudline are not known.

Missing
Lagging

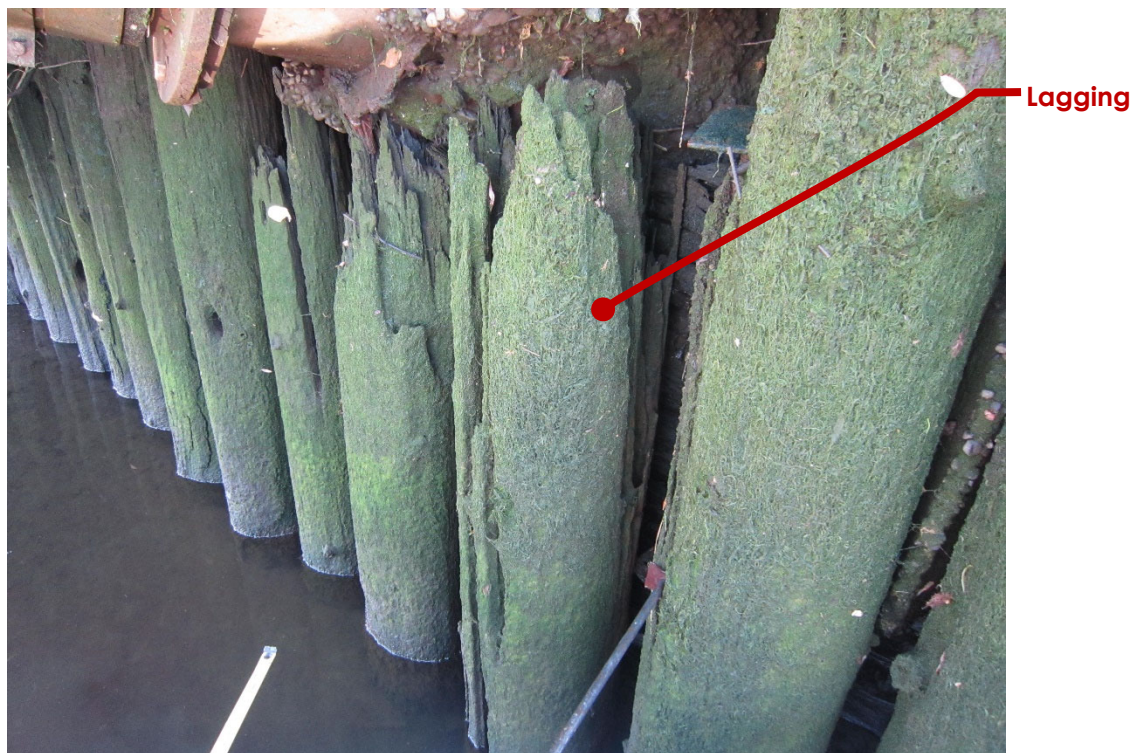
Photo ST03-25: Bulkhead Lagging Beneath Outfall

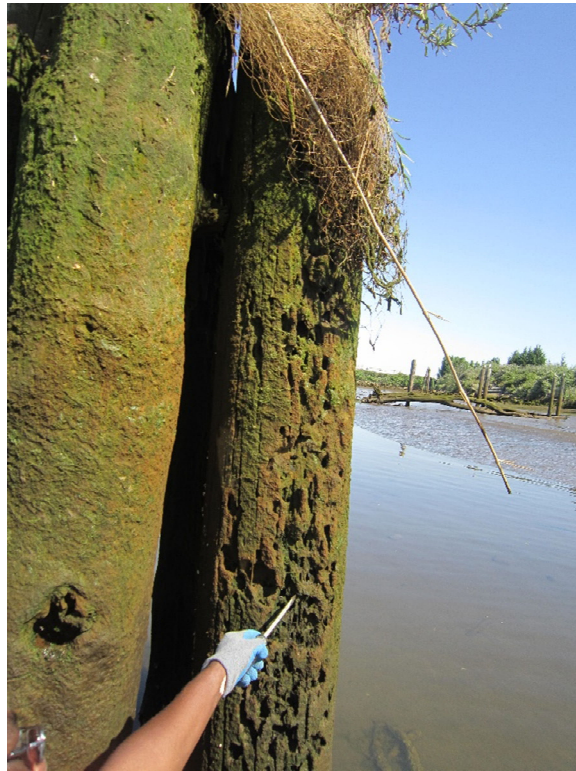
- Along the south and west side of the pier are several 7-timber treated pile dolphins; some are missing piles. The dolphins are still in use (Photo 1, 2, and 5).
- The cluster of piles are strapped together with a combination of fiber and/or strand wire rope. Some straps are broken or missing (Photos 5 and 6).
- Some piles are eroded and have lost material thickness. However, the core appear to be sound (Photo 7).

Photo ST04-07: Closeup of Pile Damage

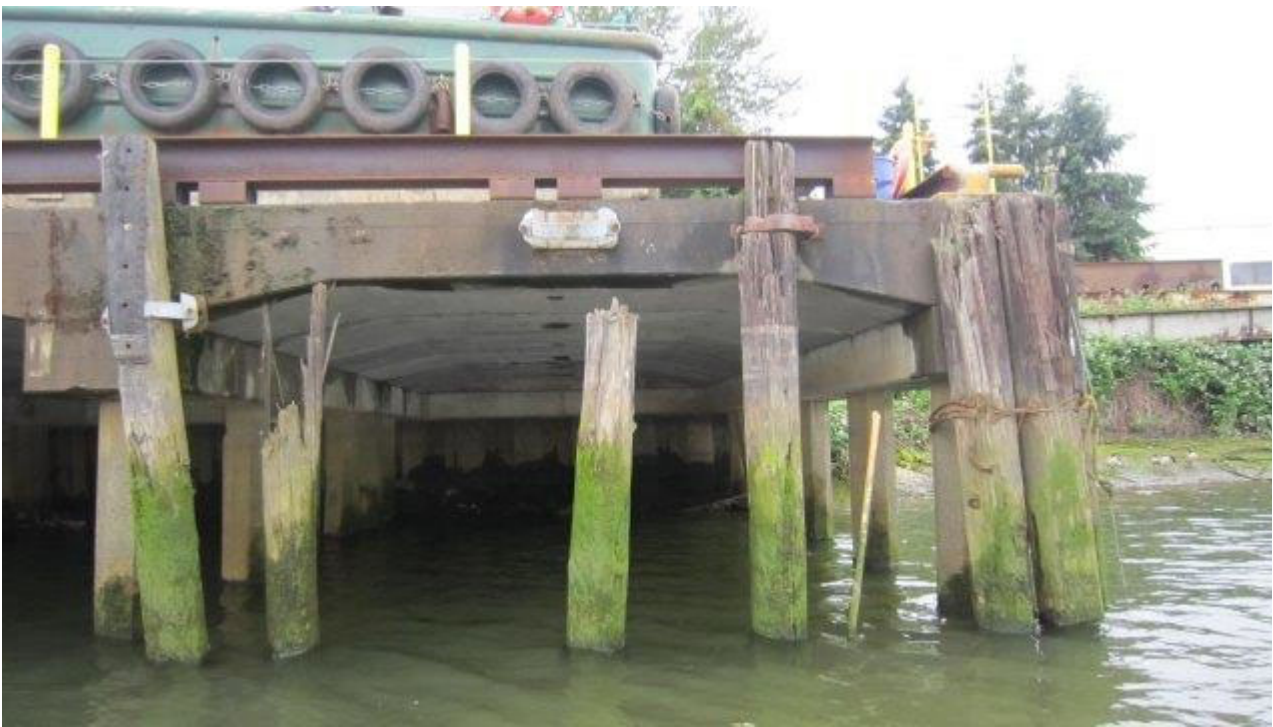
Photo ST16-016: Pier 4 Pier Deck (North Most, Looking West)

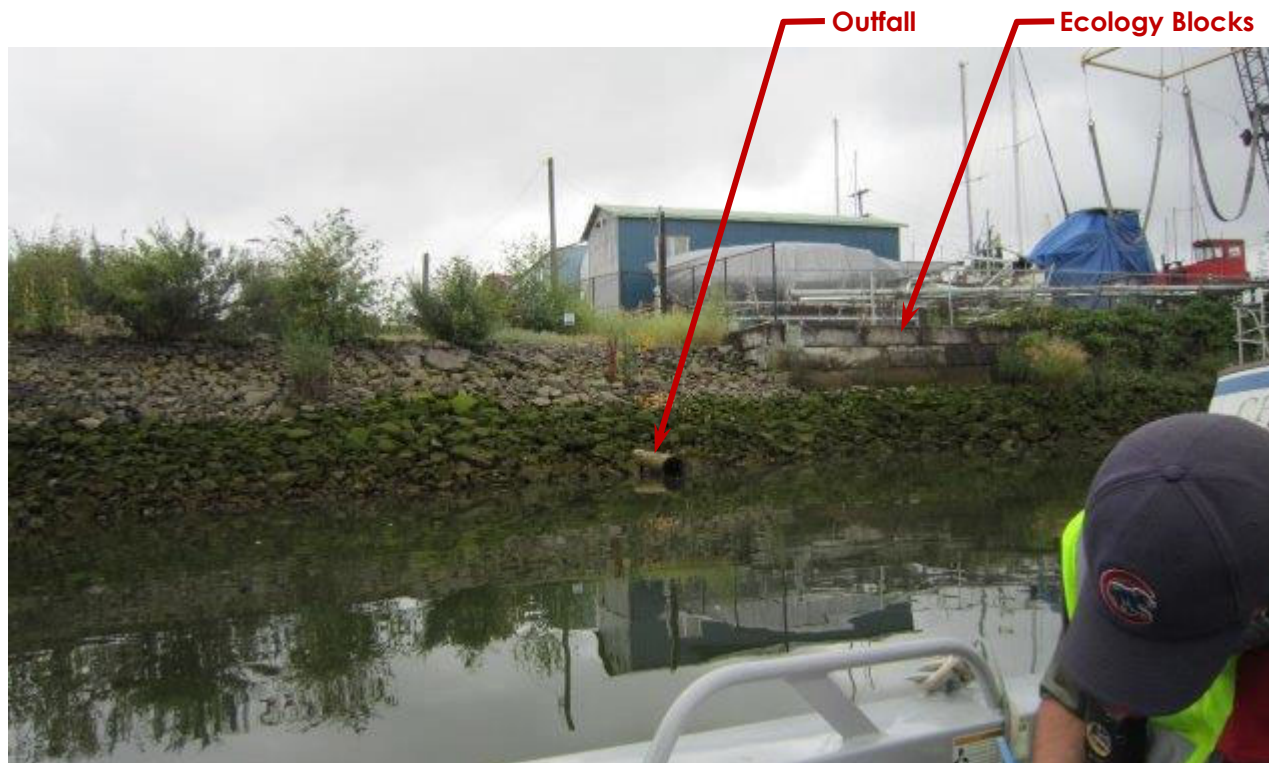
Photo ST20-01: Retaining Wall Bulkhead (Looking Northwest)

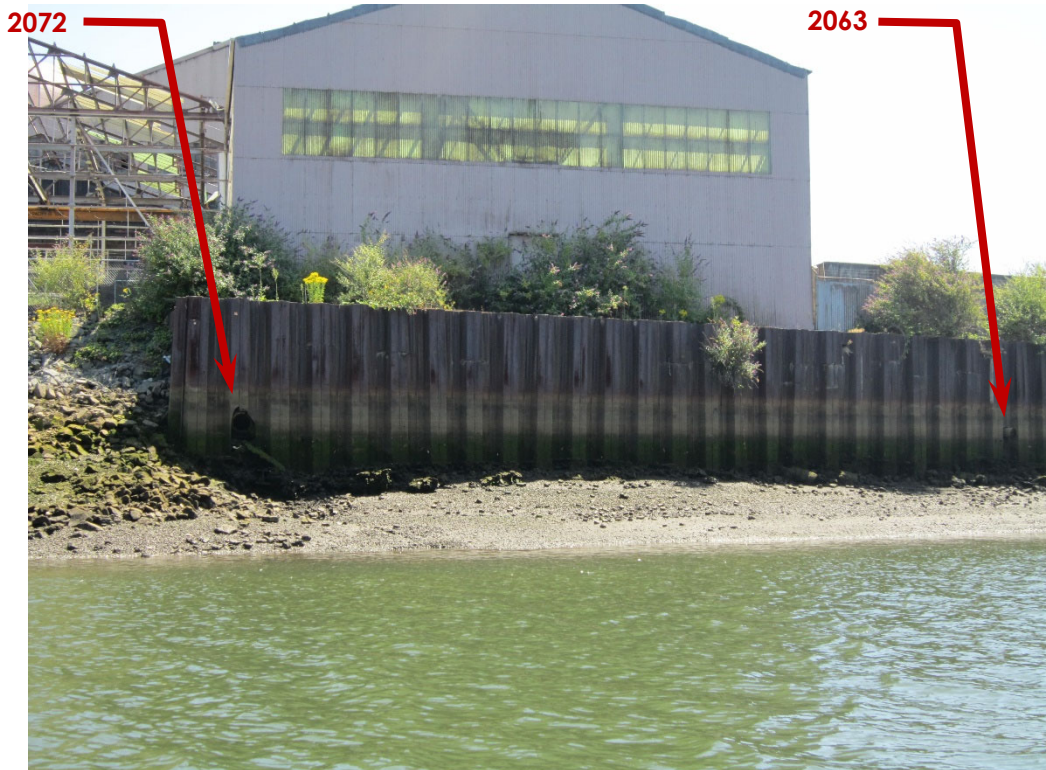
2072-01: Concrete Outfall at Low Tide

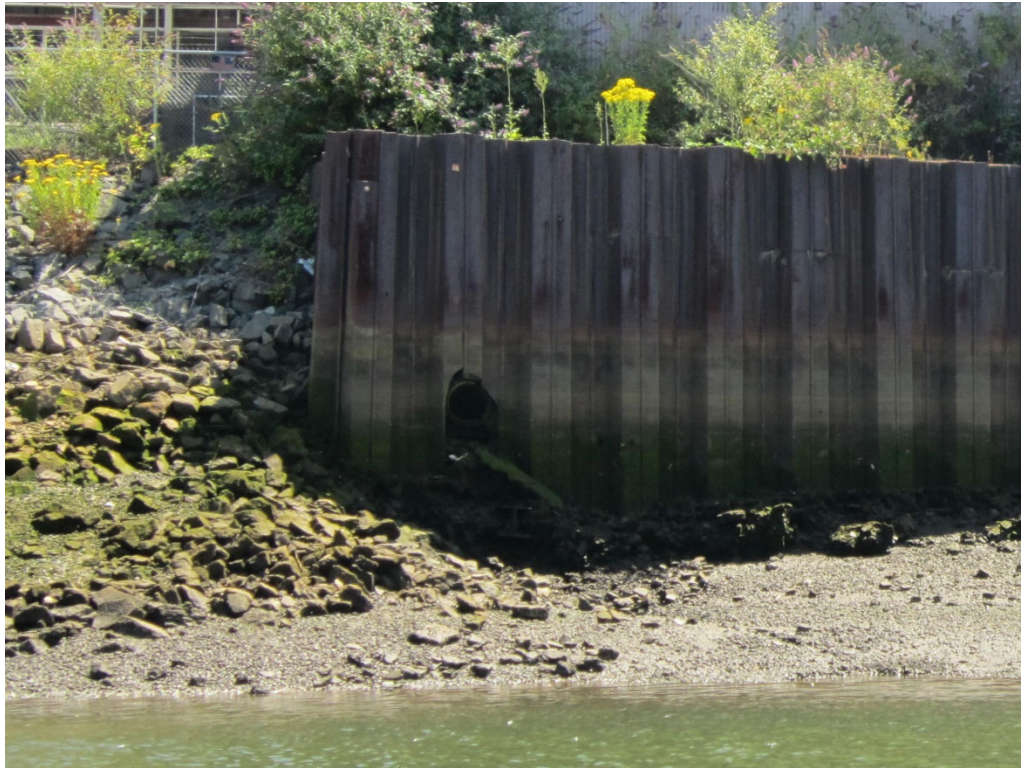
2072-03: Concrete Outfall at Low tide

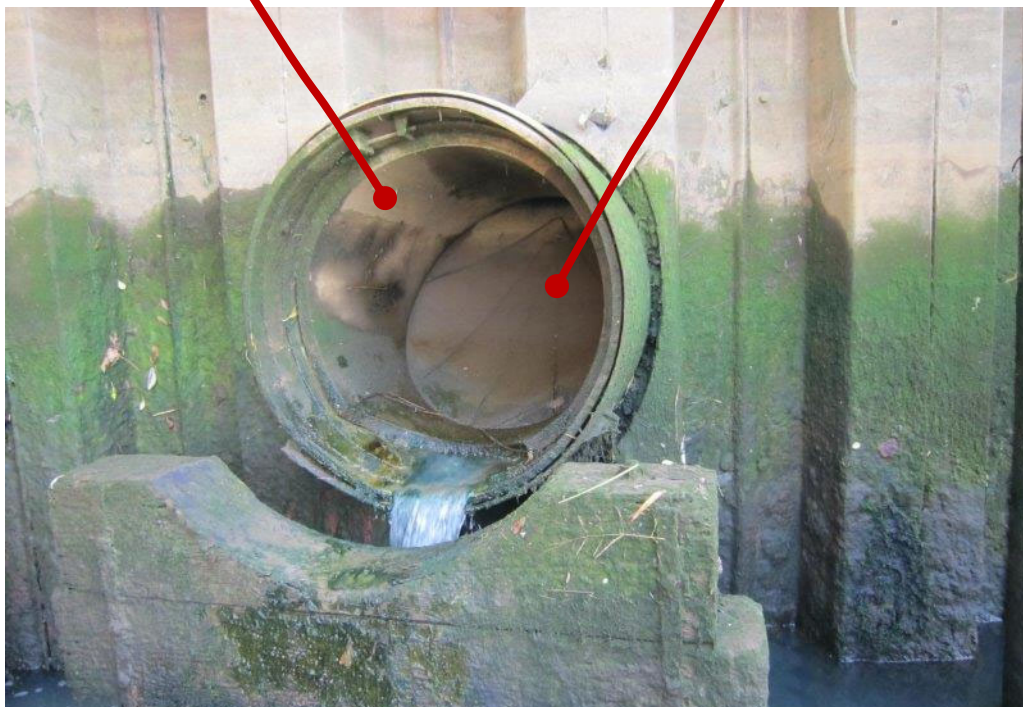
2062-04: Pipe End

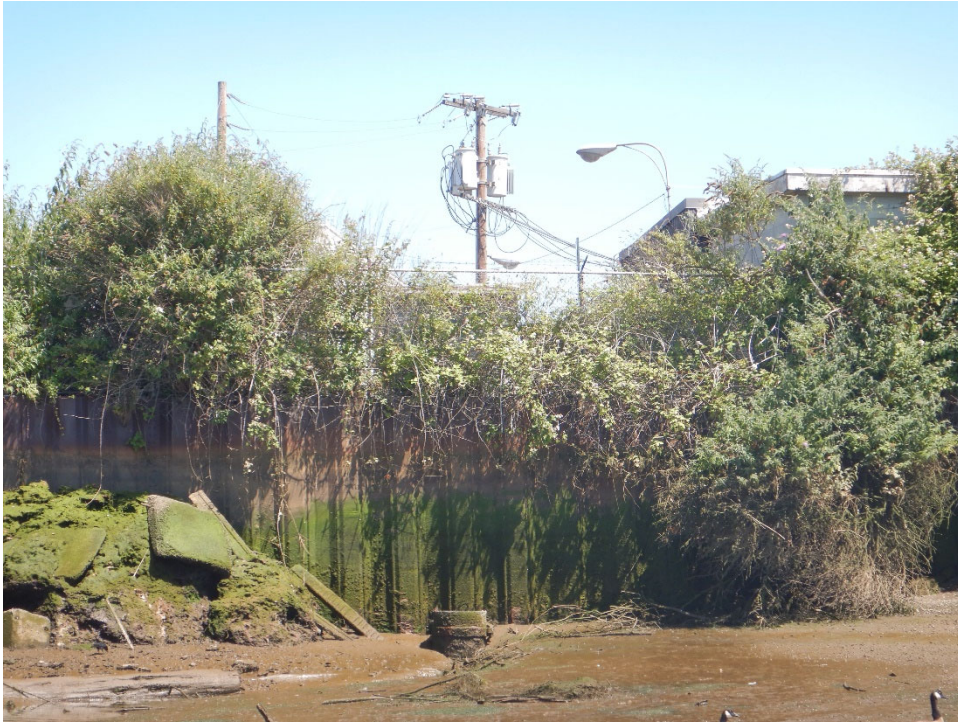
2075-01: Outfall

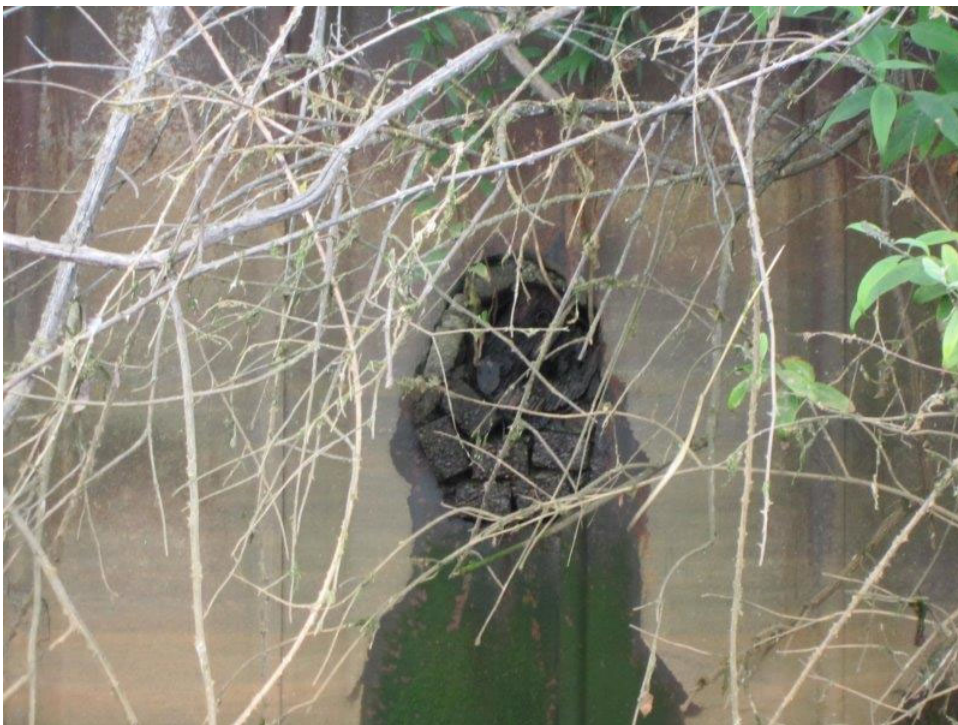
2074-02: Outfall

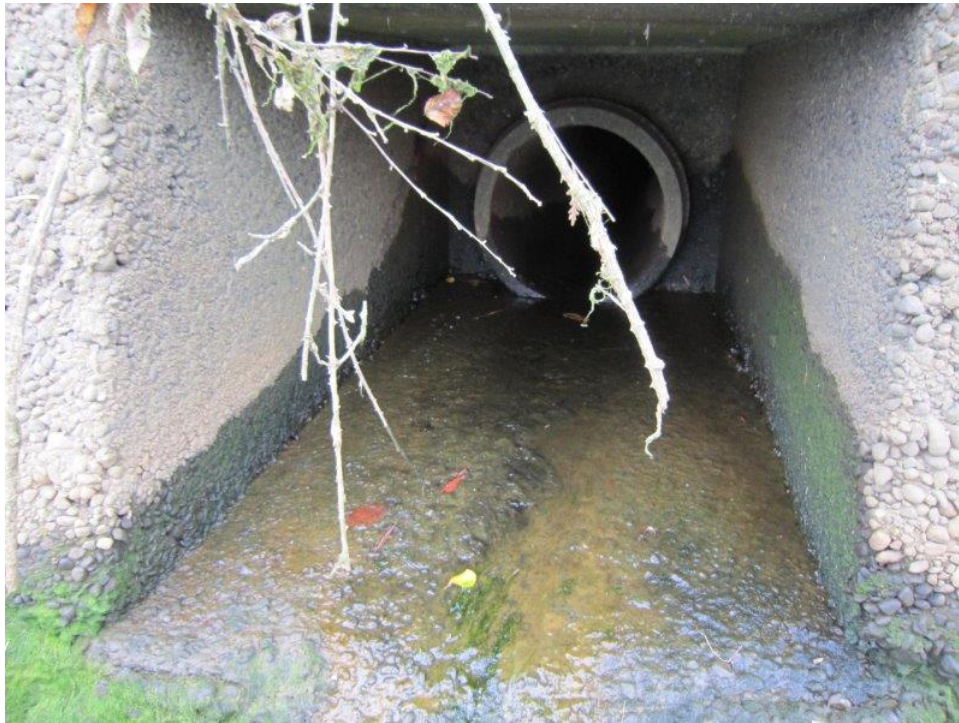
2073-03: Close Up of Outfall

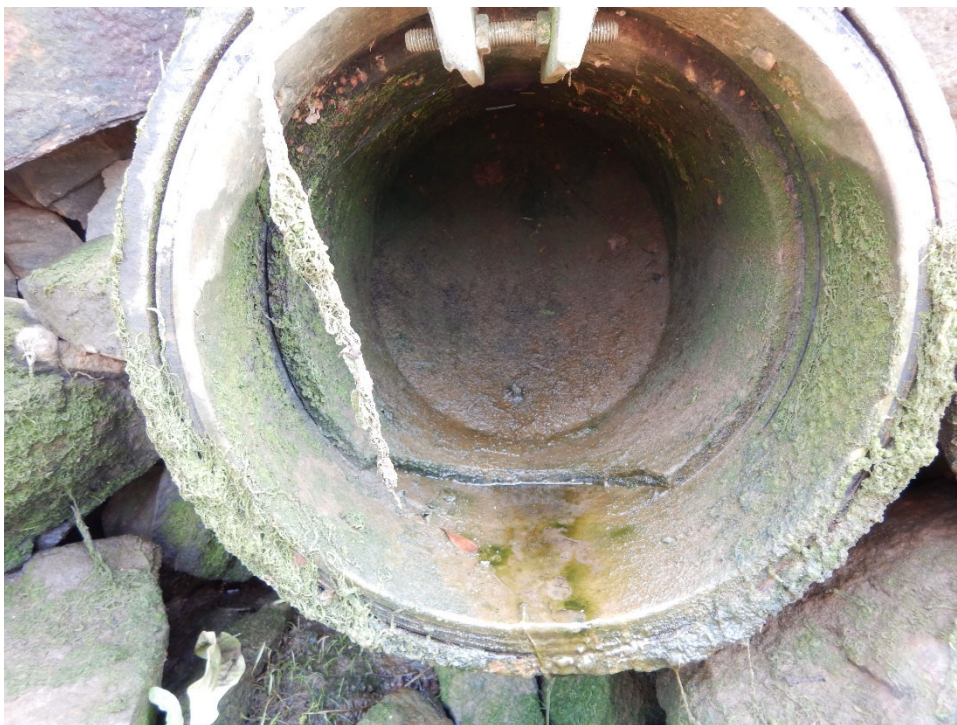
Photo 2092-04: Outfall Closeup

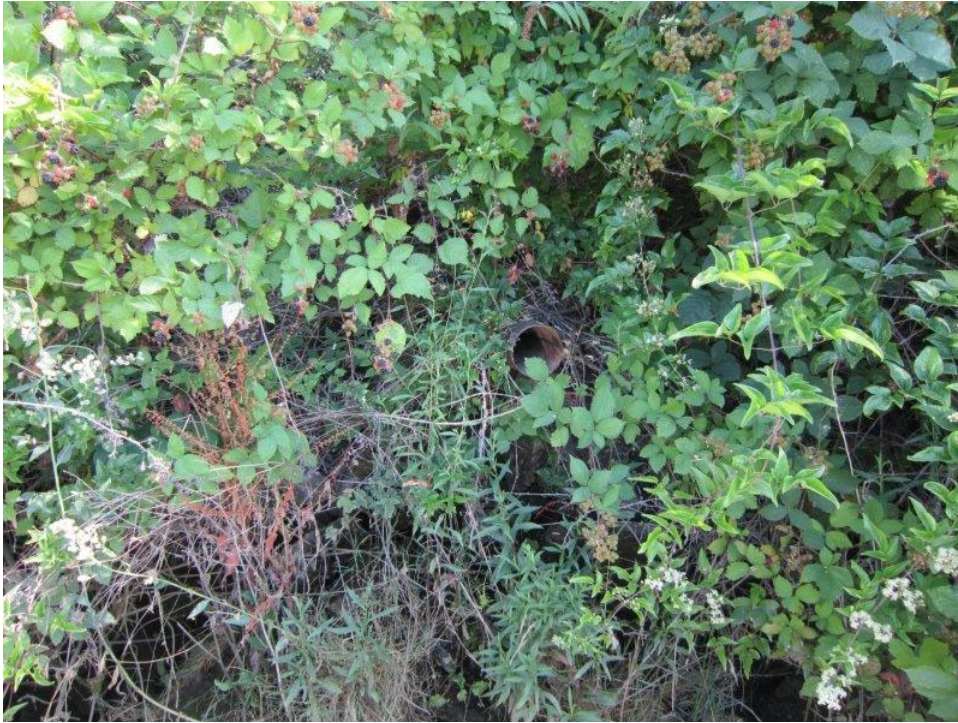
2096-03: Outfall

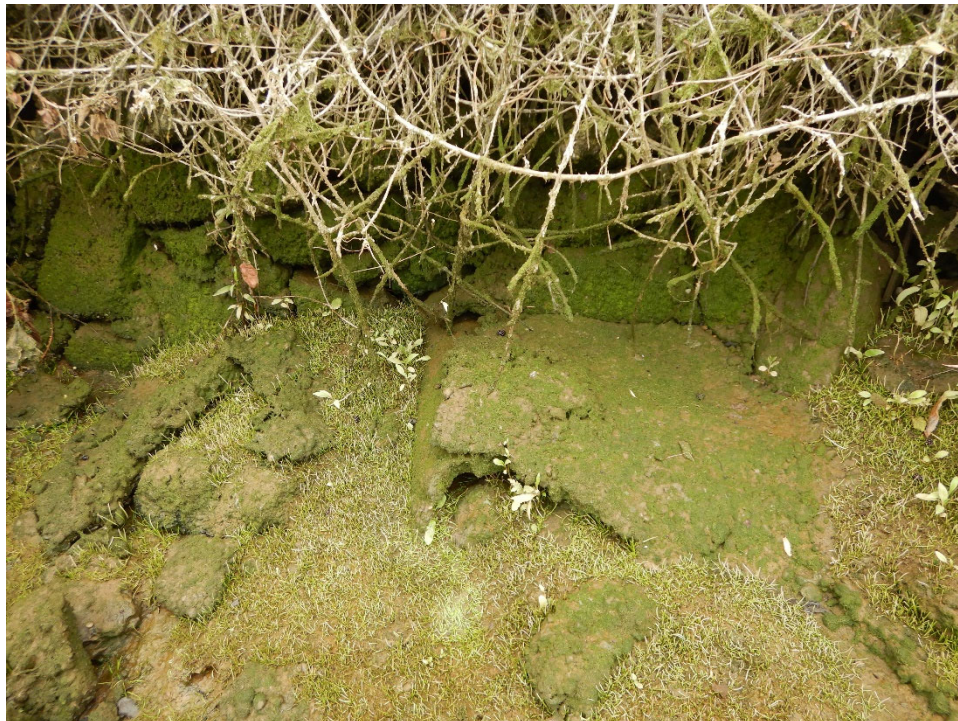
Photo 2094-02: Outfall Closeup

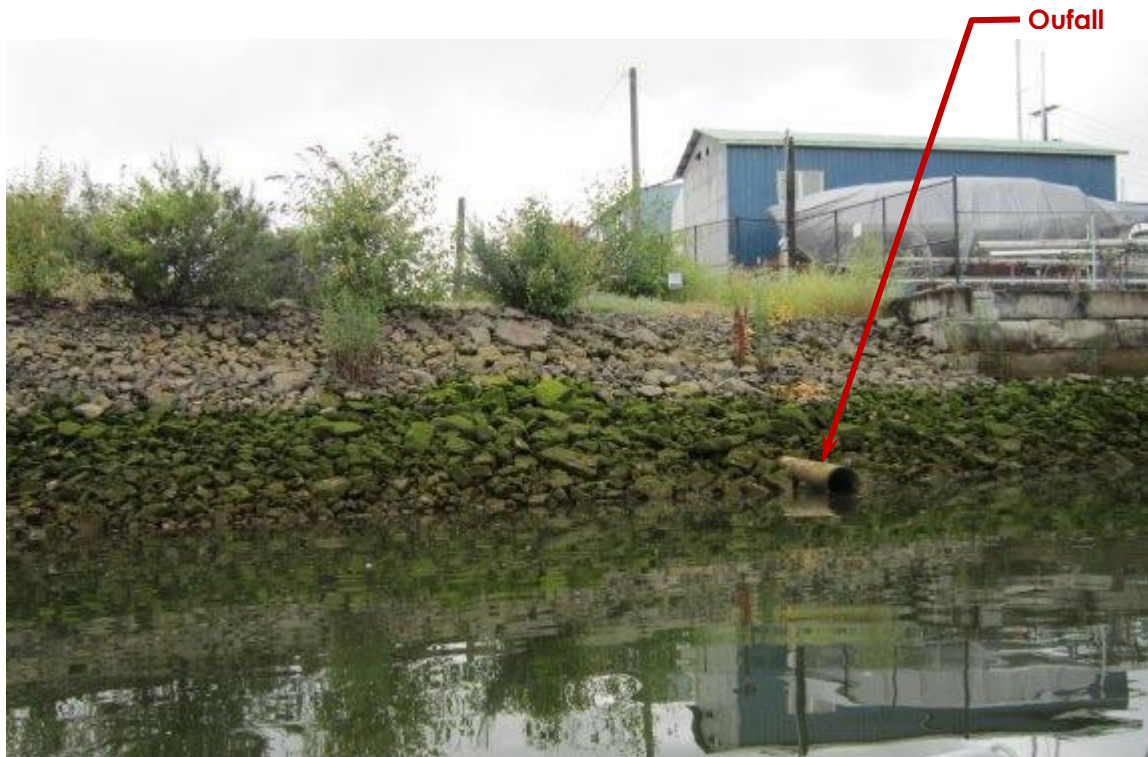
Photo 2214-01: Outfall (Looking West)

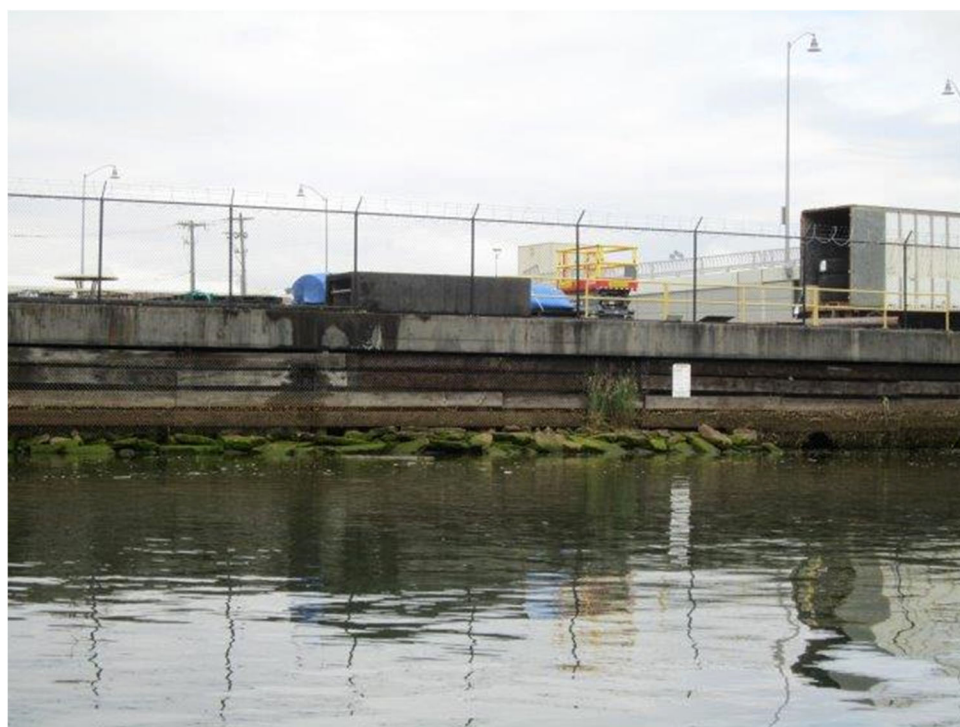
Photo ST38-06: South Apron

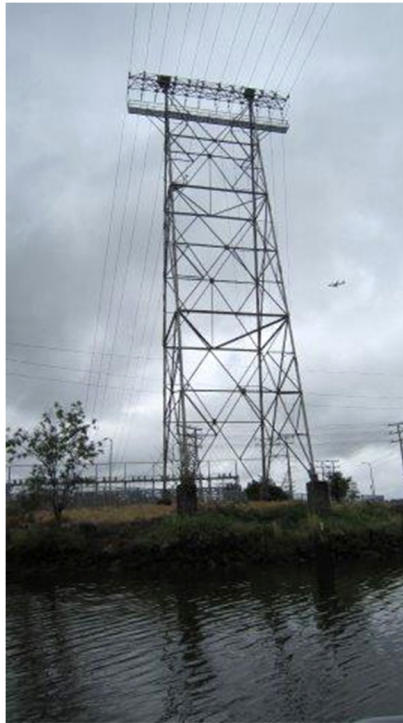
Photo ST06-05: West Tower (Looking West)

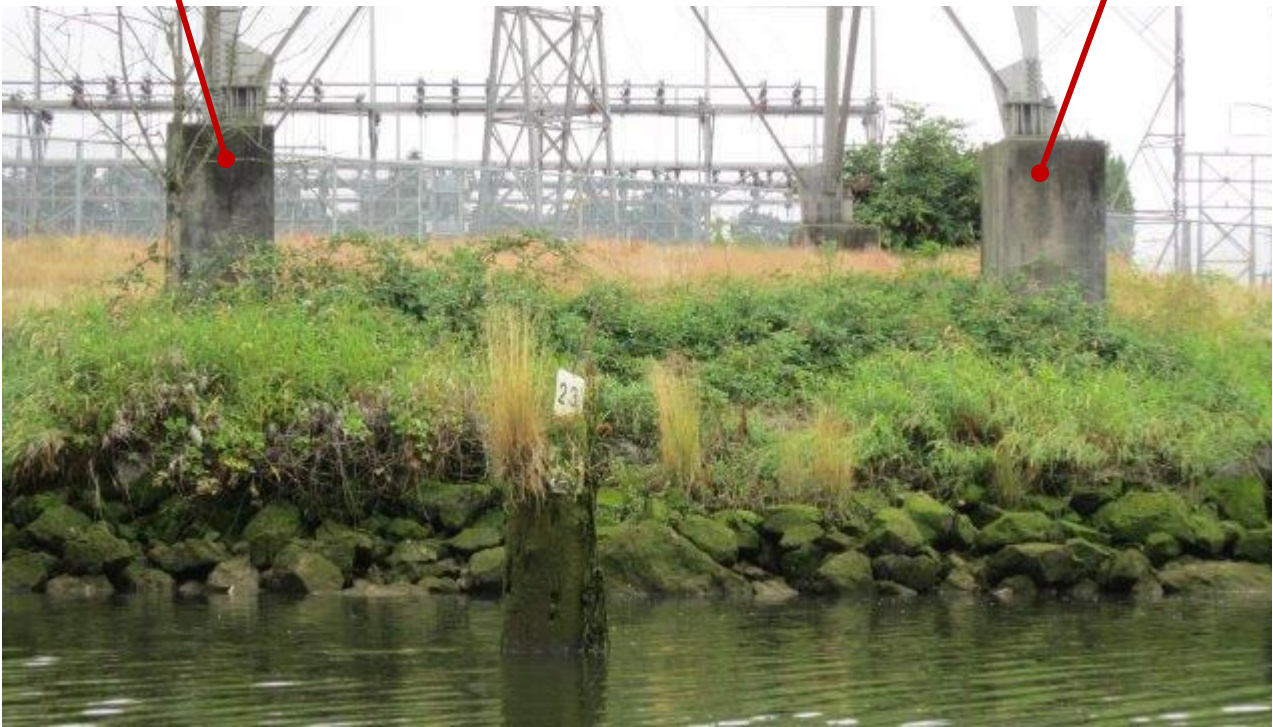
Photo ST06-06: West Shoreline

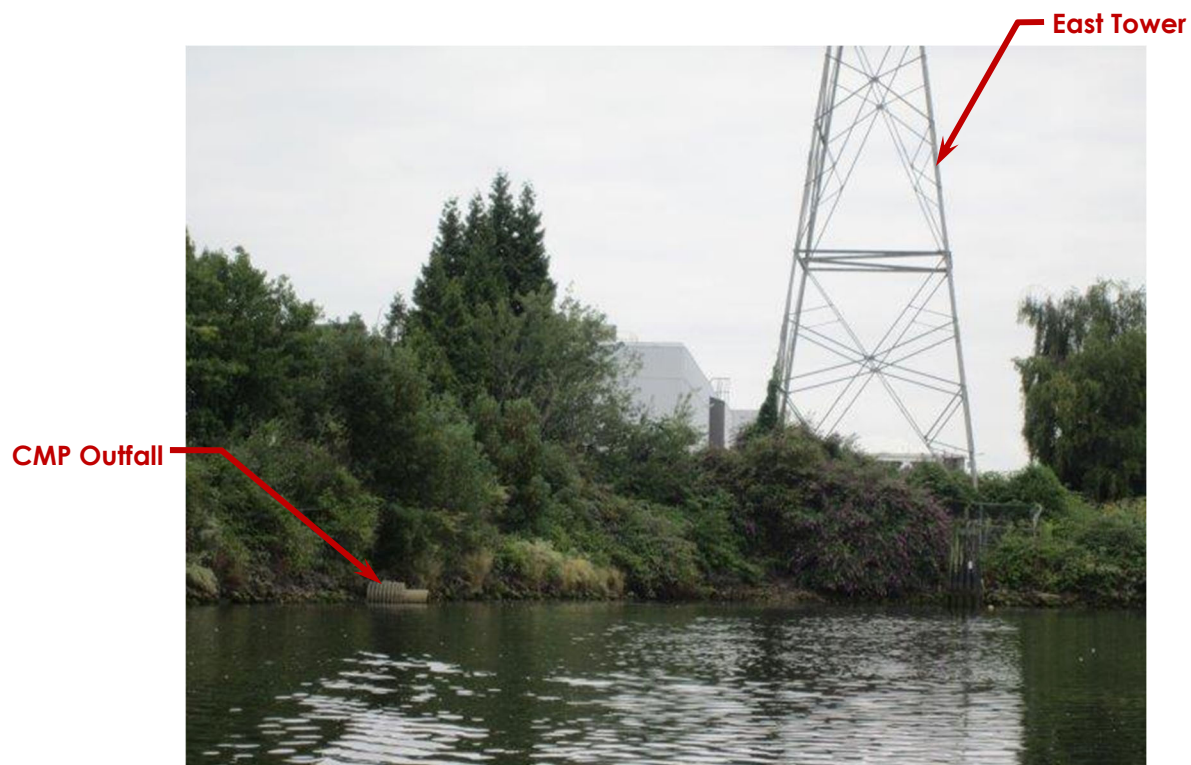
Photo ST06-07: East Shoreline

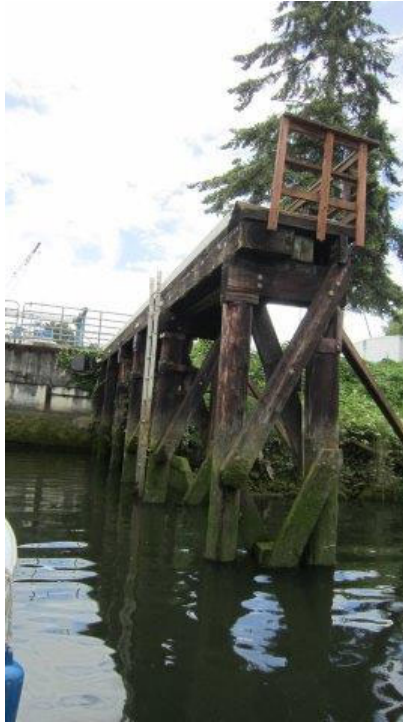
Photo ST14-03: North Bents

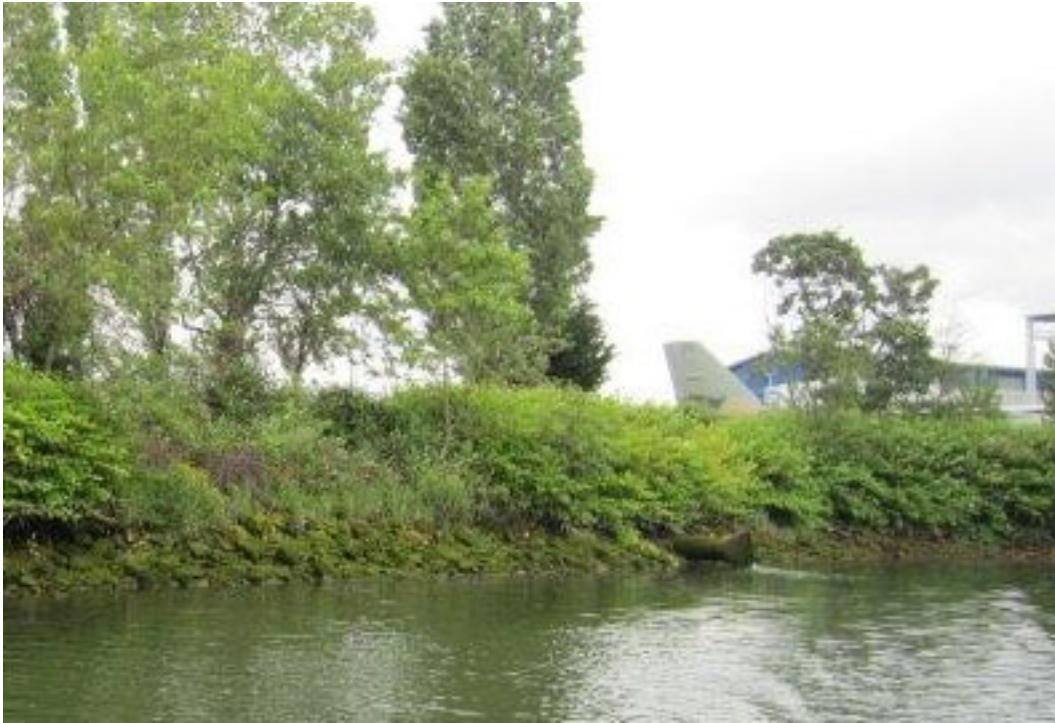
Photo 2080-01: Outfall (Looking North)

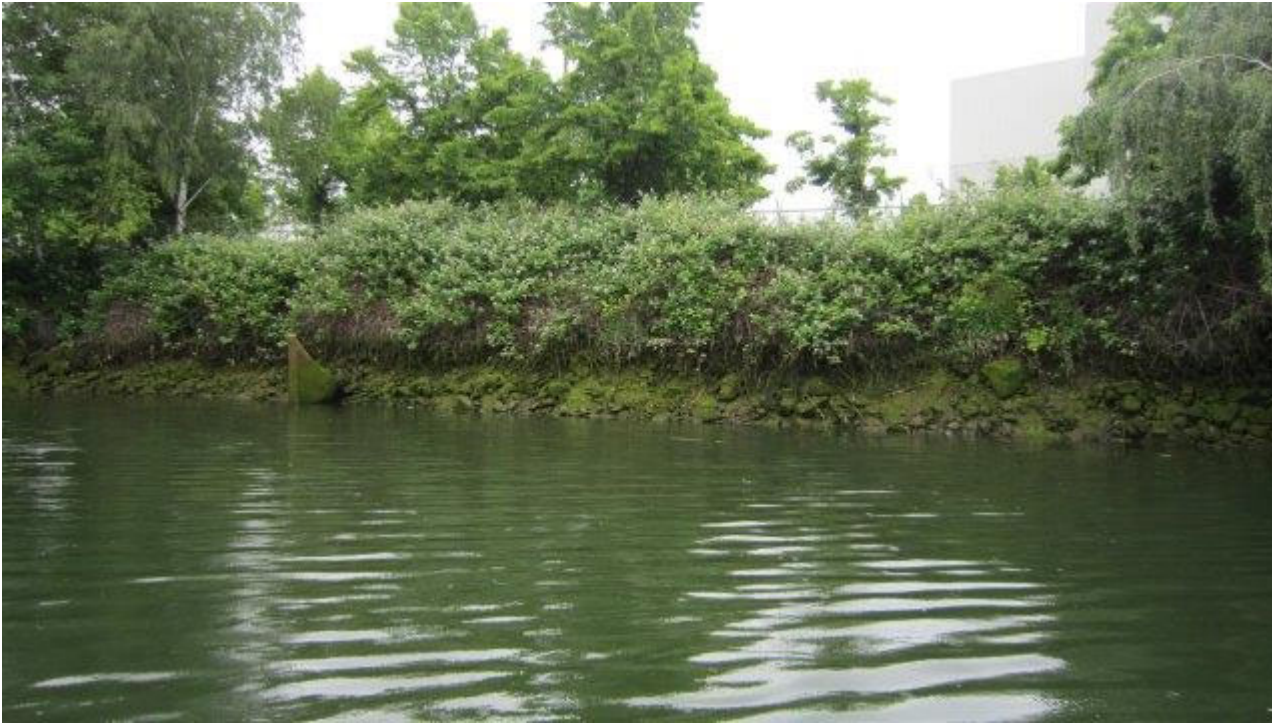
- Support stability of pipe overhang is beyond the riprap shoreline.

Photo 2081-01: Outfall (Looking North)

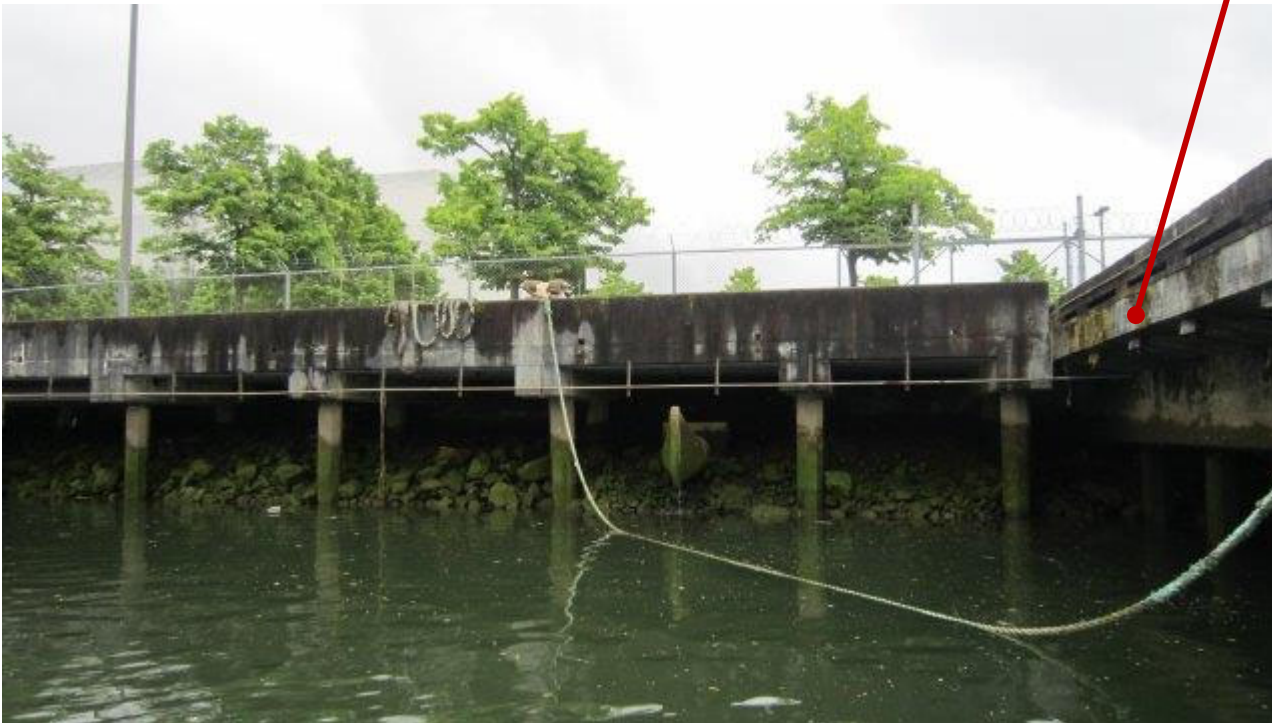
Photo 2082-01: Outfall Between Piers 4 and 5 (Looking South)

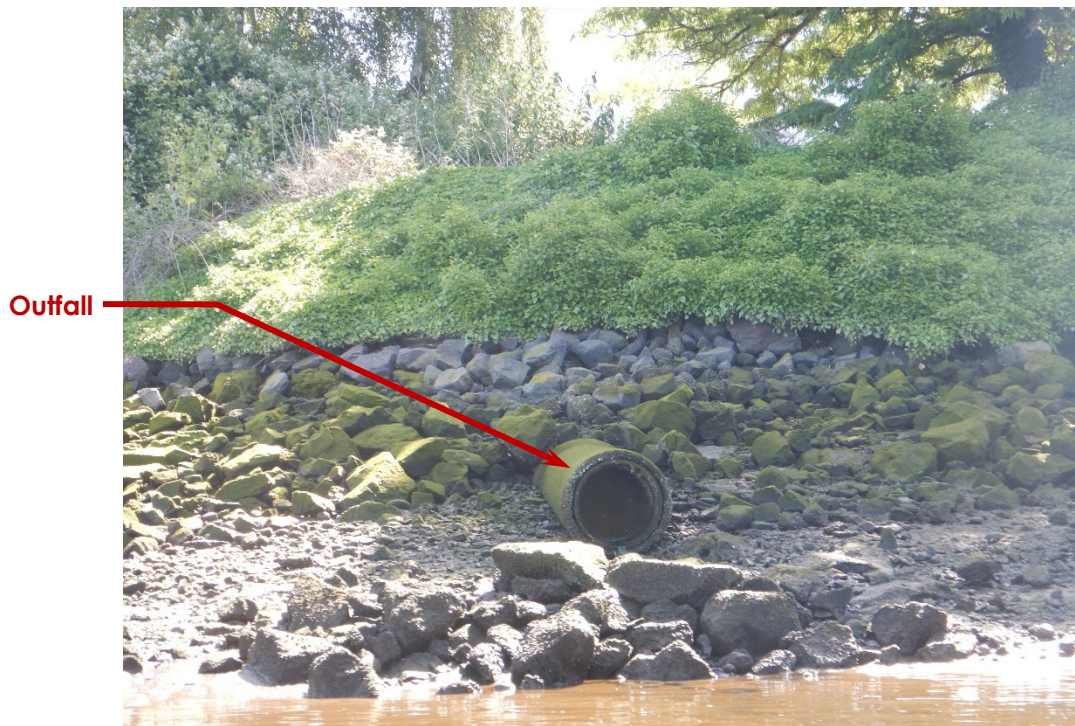
Photo 2087-01: Outfall (Looking East)

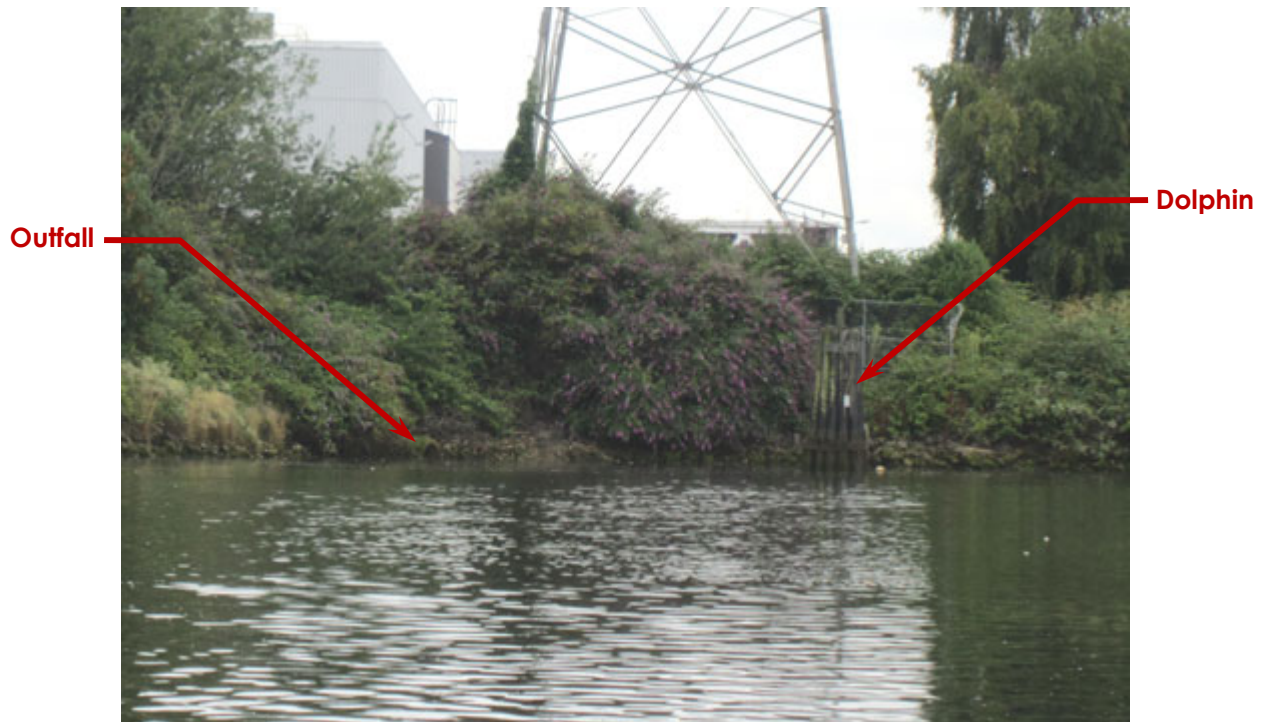
Photo 2088-01: Outfall North of Dolphin (Looking East)

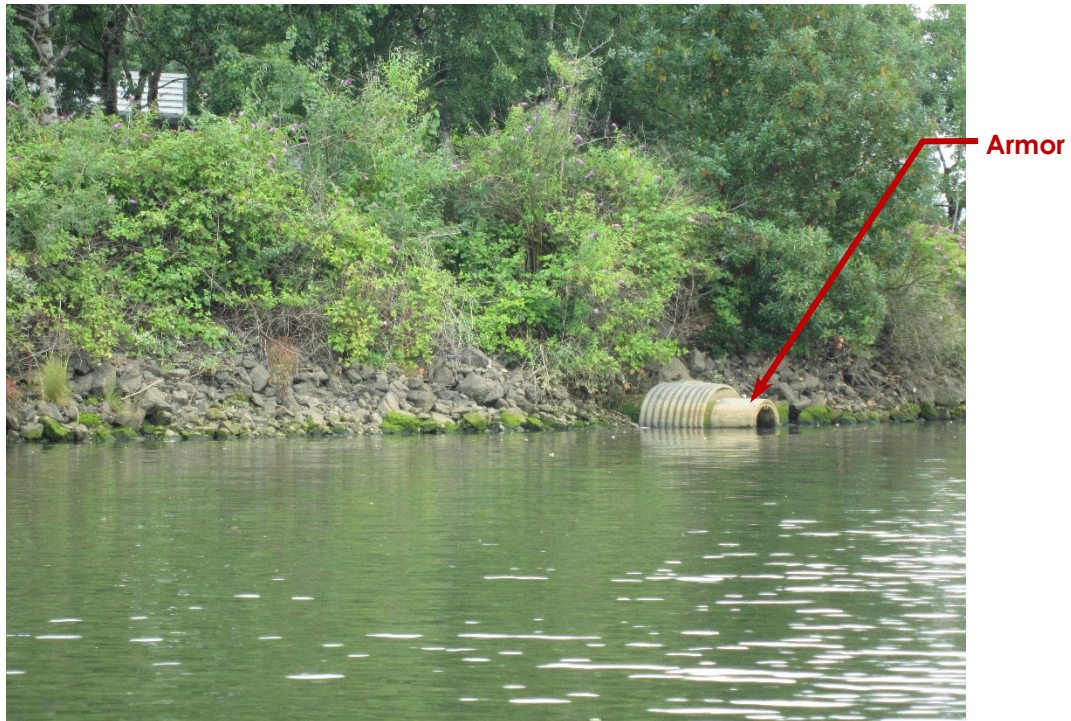
Photo 2089-01: Outfall (Looking Southeast)

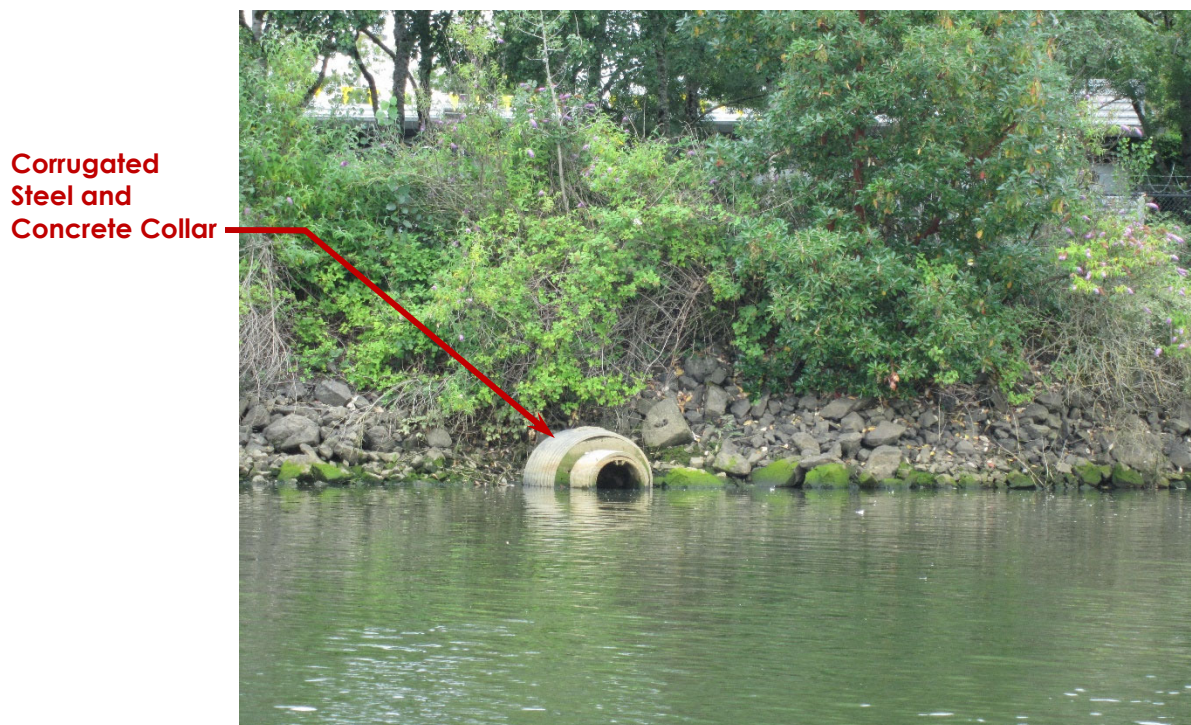
Photo 2089-02: Outfall (Looking East)

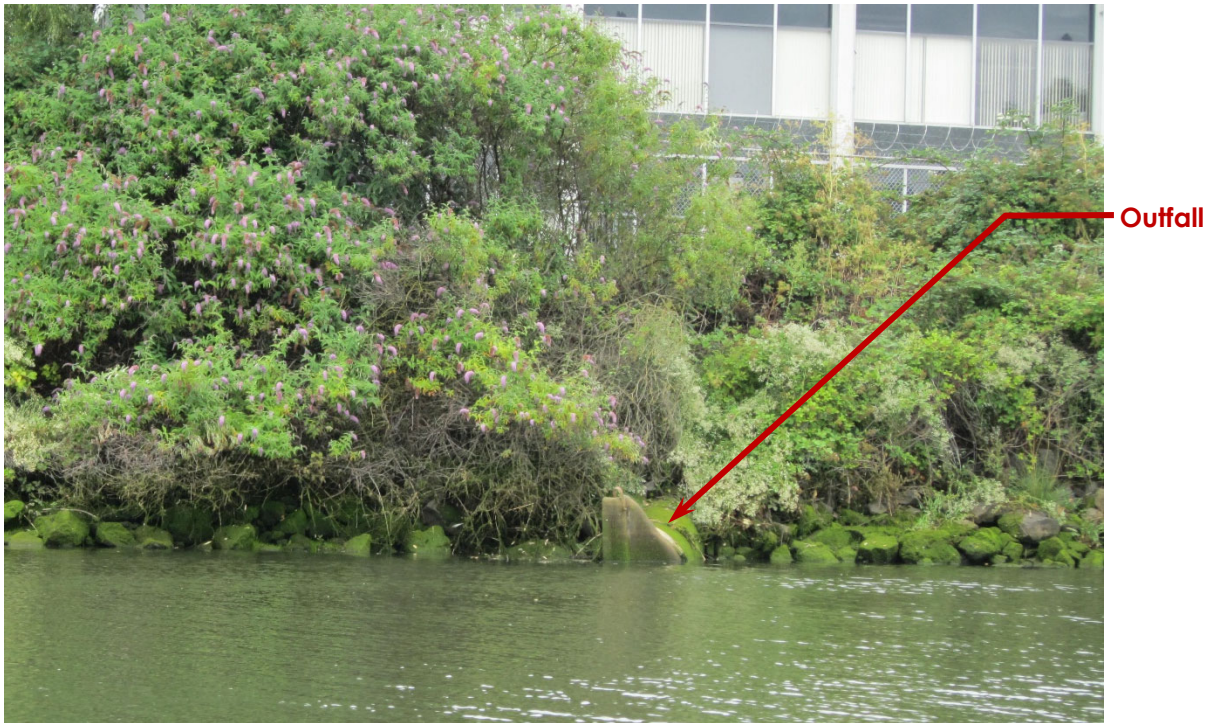
Photo 2090-01: Outfall (Looking East)

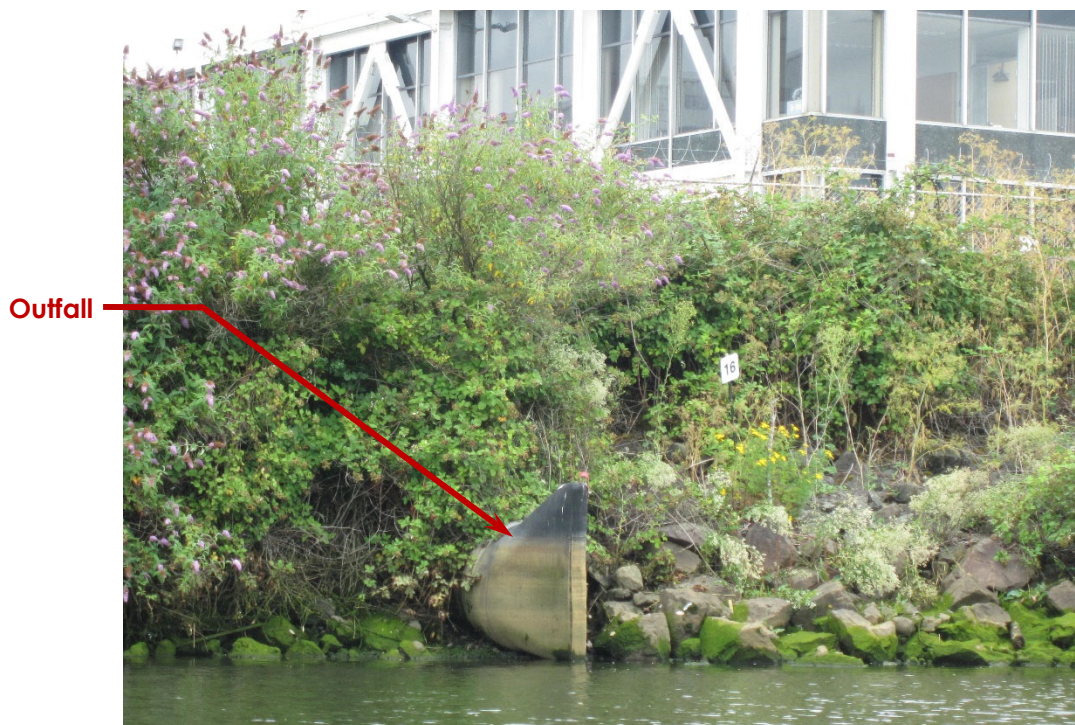
Photo 2090-02: Outfall
